Case Study: Interstate 40 Bridge Reconstruction; Webbers Falls, Oklahoma

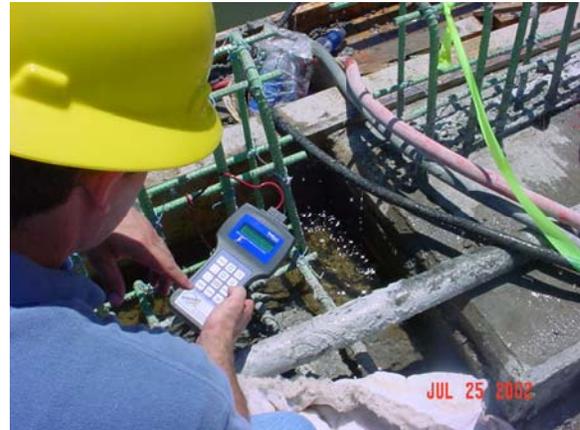
An engineer takes a strength reading at the I-40 bridge construction site using IntelliRock.

By contrast, the IntelliRock system uses an embedded microprocessor with a high-precision temperature sensor to measure temperature and calculate maturity in real time with no permanently affixed external devices. The embedded microprocessor and sensor (called a "logger") is placed into the concrete structure and then activated using a handheld reader. The reader is then disconnected, leaving only two lead wires protruding from the concrete. Whenever a strength measurement is desired, the handheld reader is simply reattached to the two wires and the current temperature and maturity is displayed. In addition, a history of temperature and maturity values and time-stamped minimum and maximum temperatures can be viewed and then downloaded to a personal computer in a secure, unalterable format.
